Caselton Mine Area Project Update

Pioche, Nevada

April 11, 2017

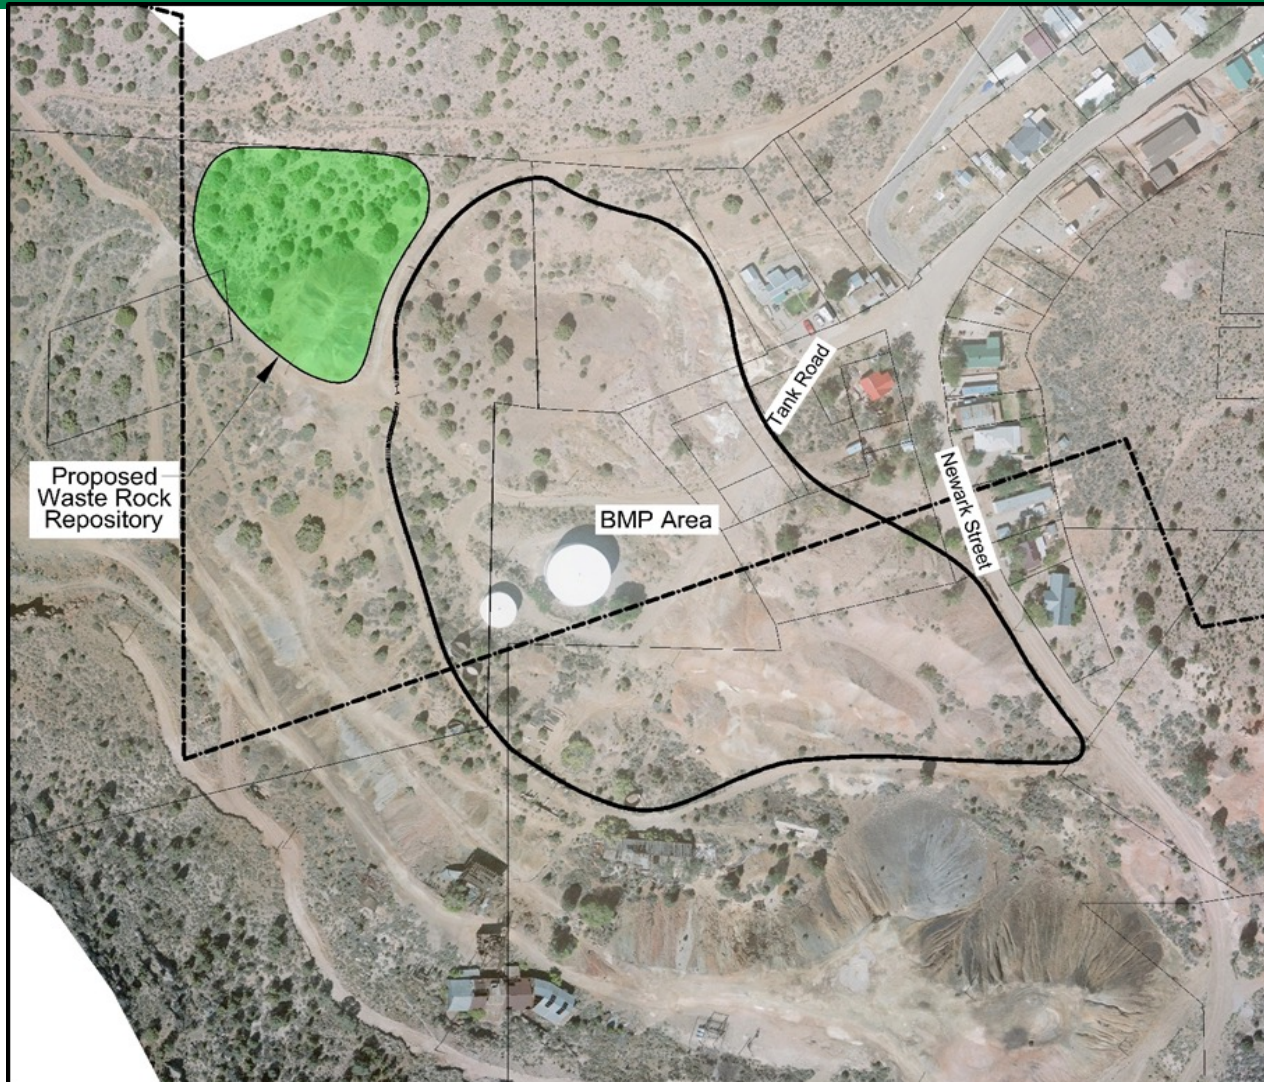
Proposed Location of Treasure Hill OU-1 Waste Rock Repository and BMP Area

- Sediments Run Down Treasure Hill with Storm Events
- To Manage OU-1 Transport of Sediment, Will Design & Construct:
 - ✓ Covered Off-Site Soil Repository
 - ✓ Improvements on Treasure Hill (known as “BMPs”)
- BMPs May Include: Grading, Vegetation, Flow Control Features & Sediment Basins
- Town of Pioche and Lincoln County Will Have Input into BMPs
- BMPs not planned to contain 100-year event, but will balance the reduction of sediment transport to streets with O&M efficiencies
- Construction Planned to Start in 2018

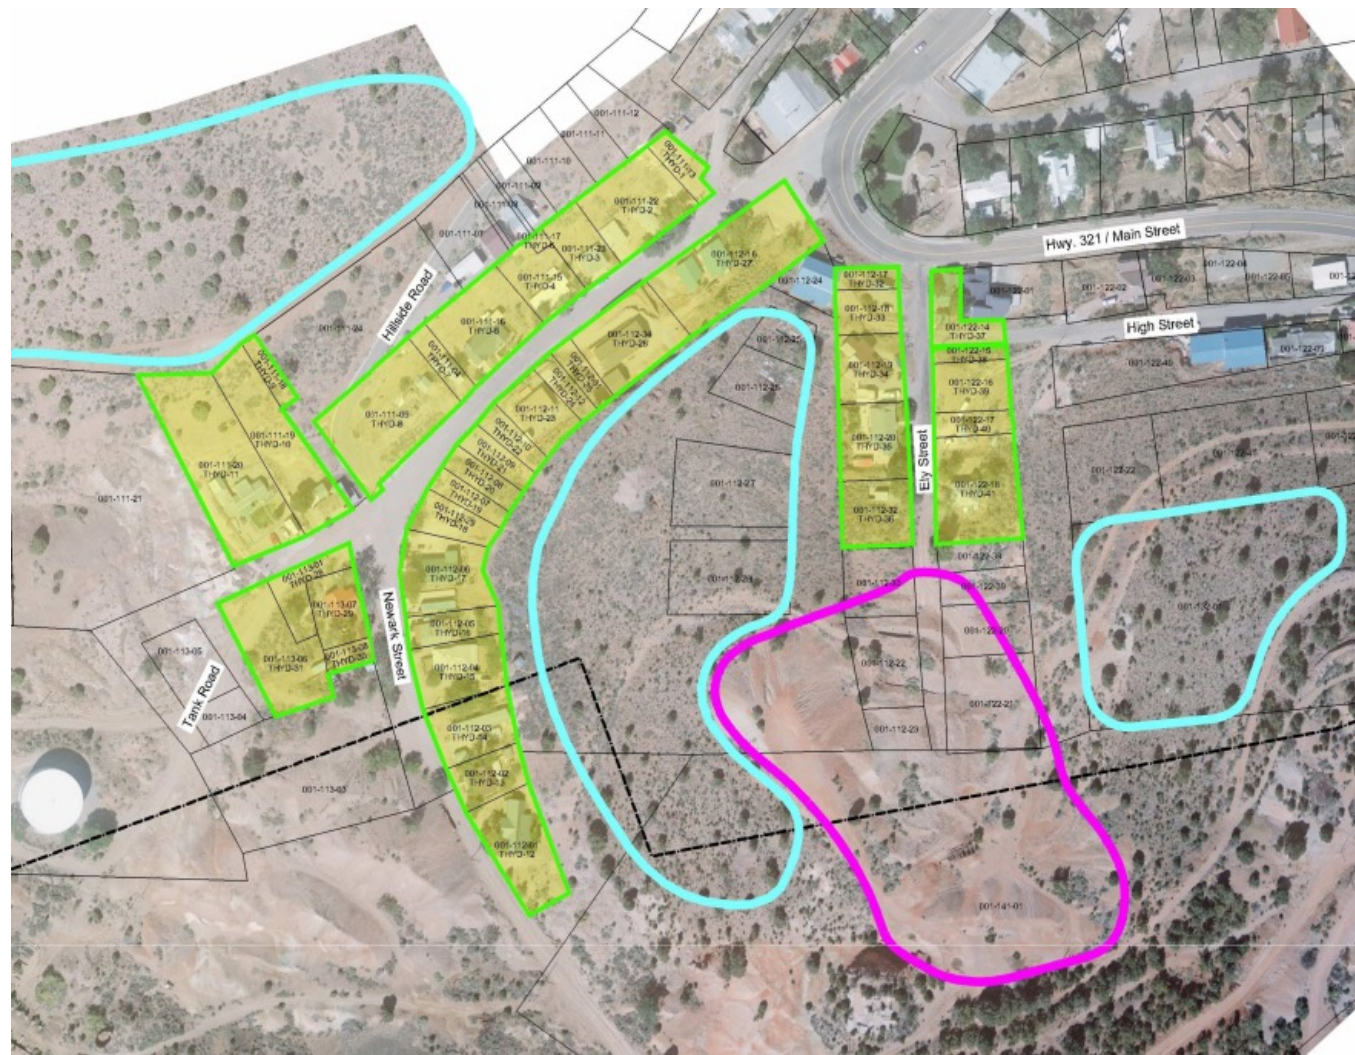
- Parcels Selected for Yard Sampling in 2016

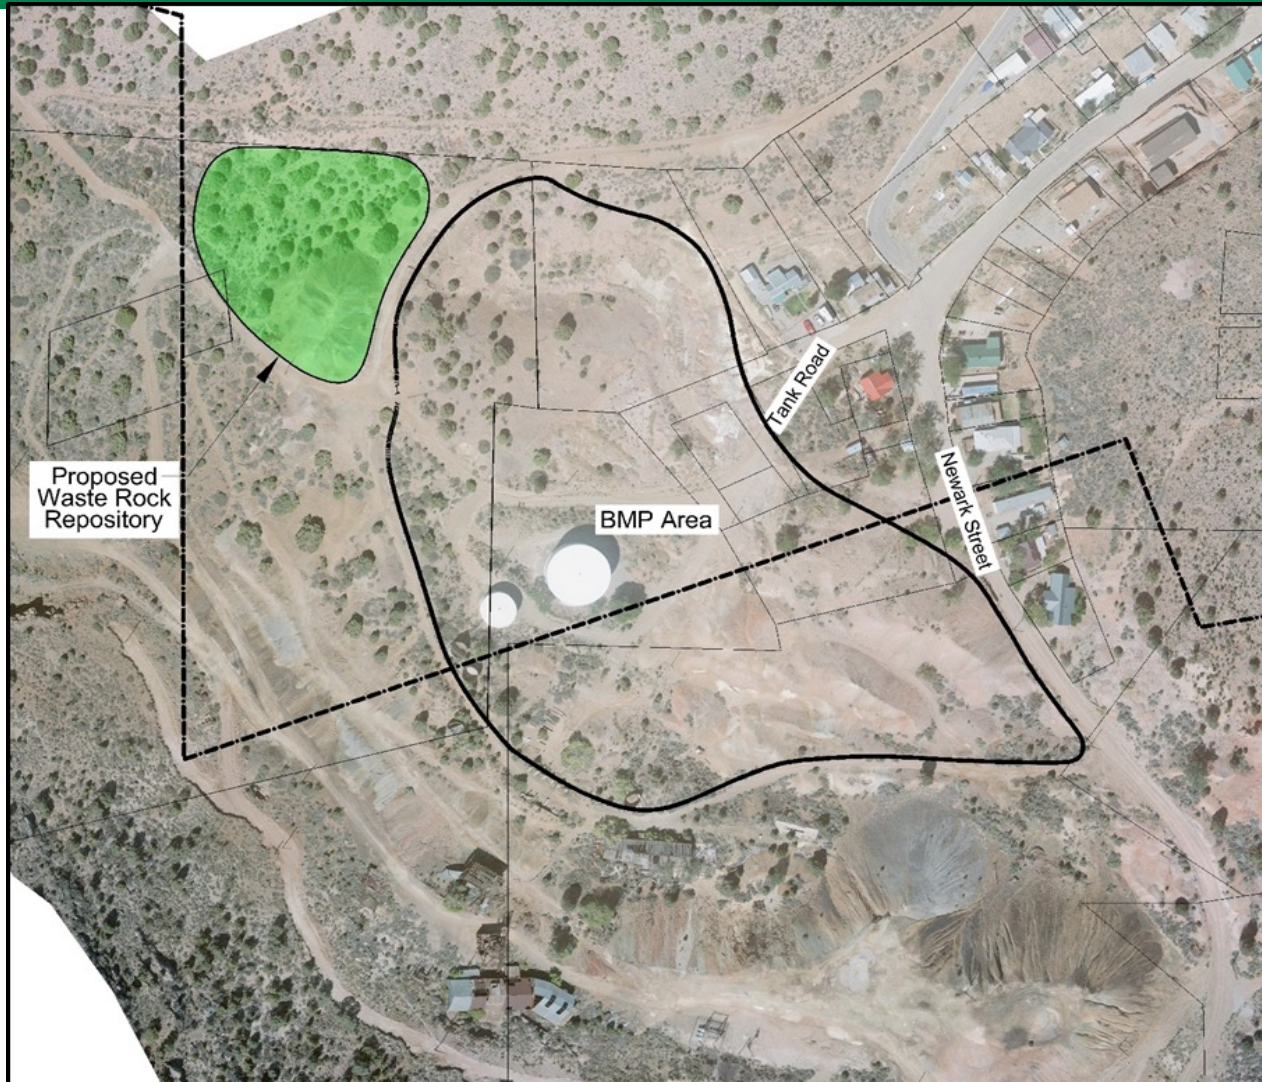
Proposed Location of Treasure Hill OU-1 Waste Rock Repository and BMP Area

5. Implement Stormwater Controls above Tank Road & Newark/Ely Streets to Manage Downhill Sediment
6. Install Curb-and-Gutter System or Retaining Walls Newark & Ely Streets to Limit Future Sediment Deposits on to Yards
7. Consolidate Waste Rock Piles Below View Shed Into Single Repository

Retrofit Curb and Gutter as Needed

Retaining wall or curb and gutter if road is paved

Possible Curb and Gutter at Ely Street or Retaining Wall (TBD)

Start of Curb and Gutter at Newark Street

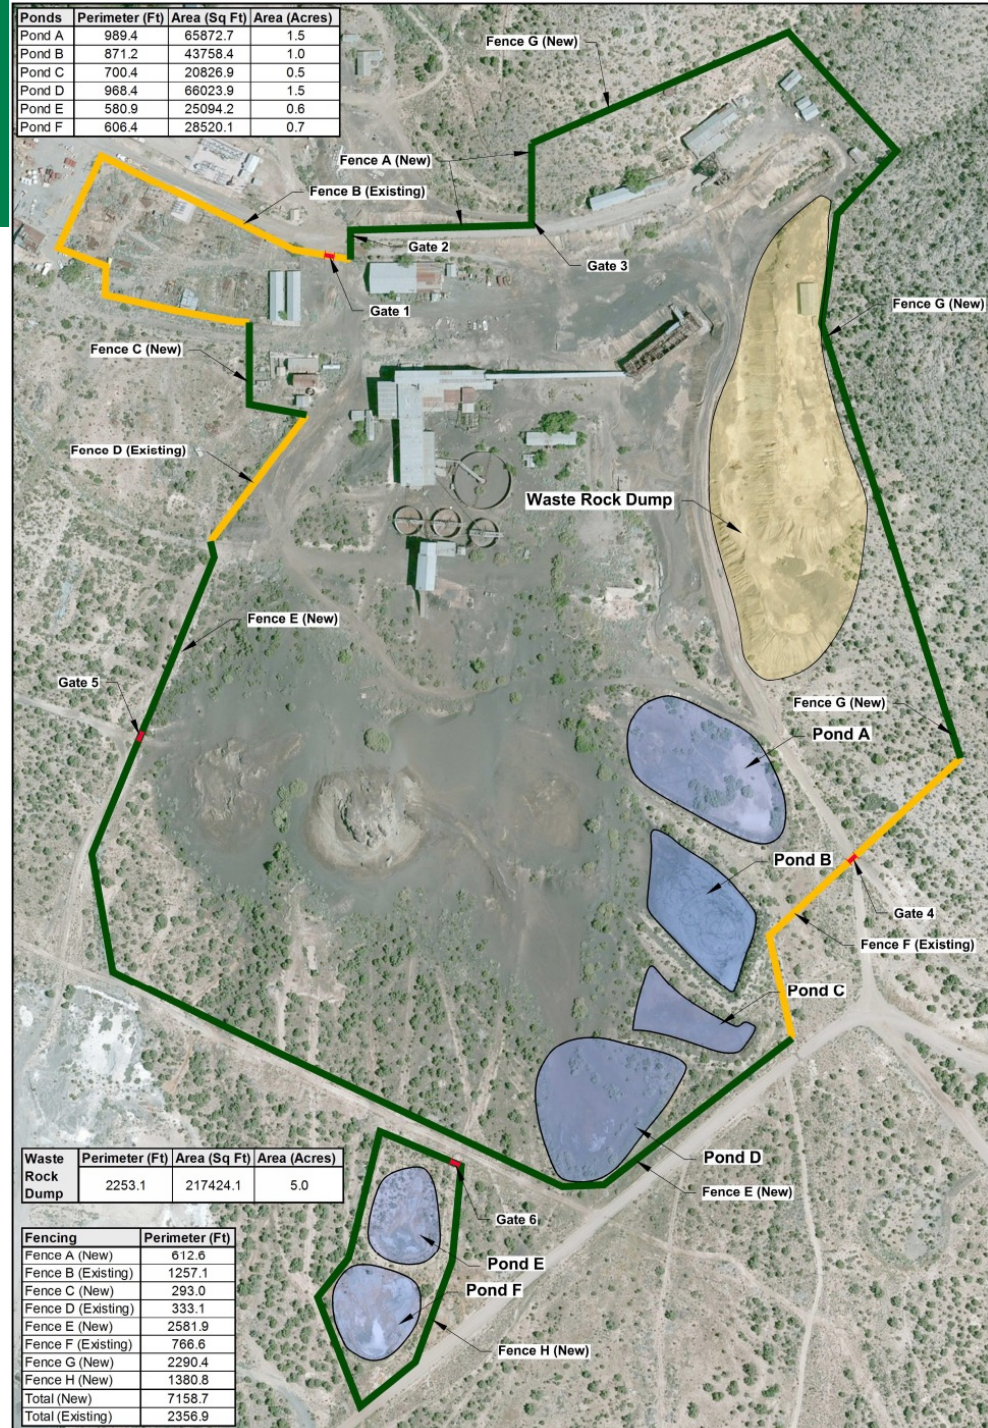
- Aerial Imagery (1996 and 2016) Indicates Stable Conditions
- Based on Predominant Wind Direction, Limited Impacts to Human Health
- Preliminary Remedy: Install Perimeter Fence Around Tailings & Improve Gates to Limit Access
- Post “No Trespassing” Signs

Ponds	Perimeter (Ft)	Area (Sq Ft)	Area (Acres)
Pond A	989.4	65872.7	1.5
Pond B	871.2	43758.4	1.0
Pond C	700.4	20826.9	0.5
Pond D	968.4	66023.9	1.5
Pond E	580.9	25094.2	0.6
Pond F	606.4	28520.1	0.7

Waste Rock Dump	Perimeter (Ft)	Area (Sq Ft)	Area (Acres)
	2253.1	217424.1	5.0

Fencing	Perimeter (Ft)
Fence A (New)	612.6
Fence B (Existing)	1257.1
Fence C (New)	293.0
Fence D (Existing)	333.1
Fence E (New)	2581.9
Fence F (Existing)	766.6
Fence G (New)	2290.4
Fence H (New)	1380.8
Total (New)	7158.7
Total (Existing)	2356.9

- Stormwater Run-off Analysis in Progress
- Elevated Metals Concentrations in Tailings
- Remedial Action Goal = Prevent Human Contact
- Preliminary Remedial Alternative
 - ✓ Fencing
